## SEISMIC PROTECTION OF BUILDINGS IN PERU USING ENERGY DISSIPATION AND BASE ISOLATION

### ***Abstract***

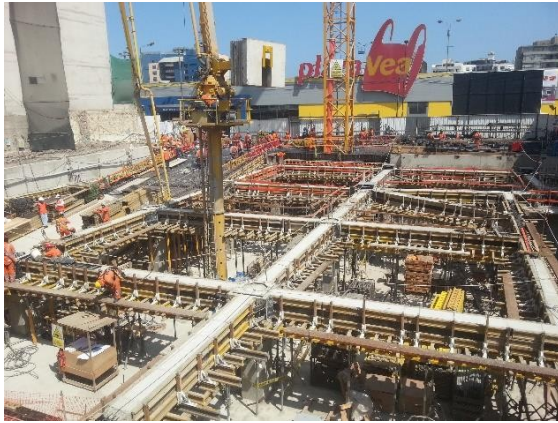
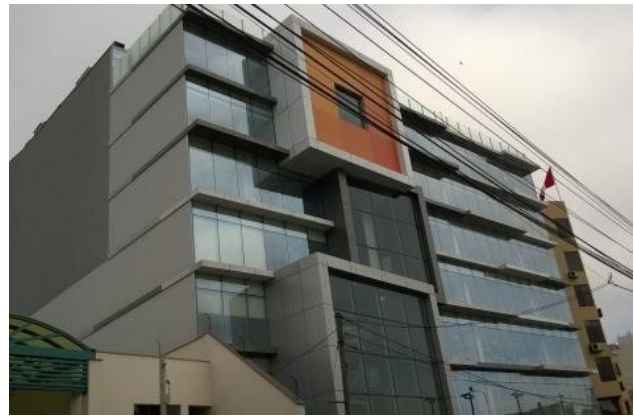
Fig. 1 “GyM” office building– Lima, Peru

The first office building with isolators built in Peru, was the building of private company GyM headquarters office (Fig. 1) designed by the structural firm "Prisma" in 2013. Regarding such building, a cost comparison was done of the isolated building with respect to a conventional design (with RC frames and walls). The result of the study conducted by Prisma and GyM, gave that the isolation system was only 3% more expensive compared to the conventional system.

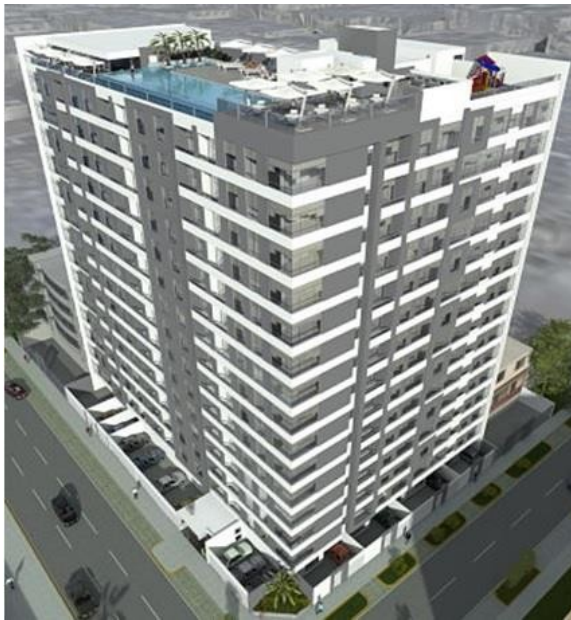
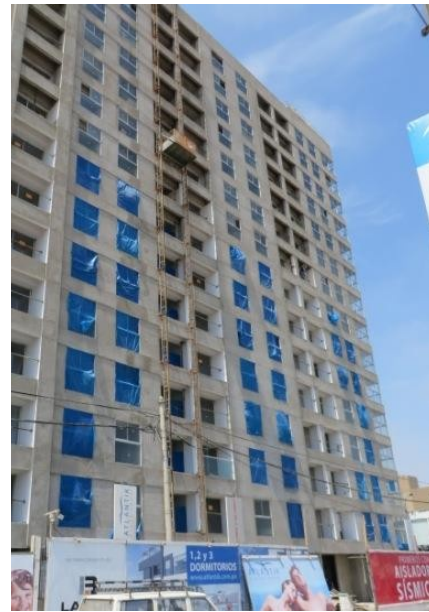
Fig. 2 “Atlantik Ocean Tower” building in Lima, Peru

In 2014, the real estate “Labok” built the first apartment building with seismic isolators called “Atlantik Ocean Tower” in which the structural design was by Prisma. This 15-story plus 4 basements building, has 40 elastomeric isolators and friction sliders (Fig.2). Subsequently, Prisma developed in 2015 the first building for economic housing apartments, using a system of seismic protection. This building called “Paseo Colonial” has started construction in May 2016; it has 15 floors plus 2 basements and 72 elastomeric isolators (Fig. 3).

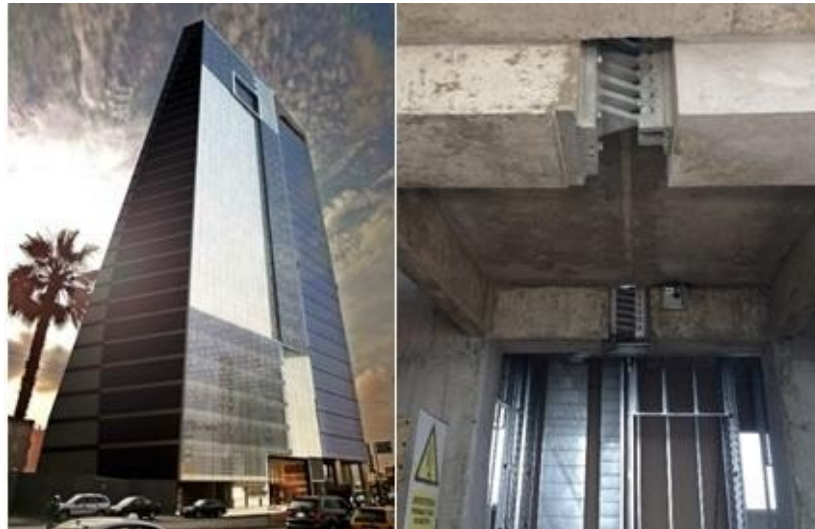
Fig. 7 “Barlovento Tower” building in Lima, Peru

Some of the most representative new buildings with energy dissipation systems in Perú are as follows. The “Barlovento Tower” is a new office building with 31 stories and 9 basements, designed with 156 hysteretic dampers TADAS, located between coupling beams that connect the structural walls of the elevators (Fig. 7). The construction of this building ended in 2015. Till now, this is the tallest building in Peru having an energy dissipation system. Also, the “Orquídeas Tower” is another office building, with 27 stories and 10 basements that finished its construction by the end of 2015. The design included 94 hysteretic dampers TADAS, in locations and distribution similar to the Barlovento tower (Fig. 8).
